3 NOISE MEASUREMENTS

This chapter summarizes the portable noise measurement program conducted in the Noise Exposure Map phase of this Part 150 Update Study. Section 3.1 summarizes measurement program objectives. Section 3.2 summarizes measurement program design and execution. Section 3.3 presents a summary of the DNL measurements. Section 3.4 presents site-by-site single event and cumulative exposure results.

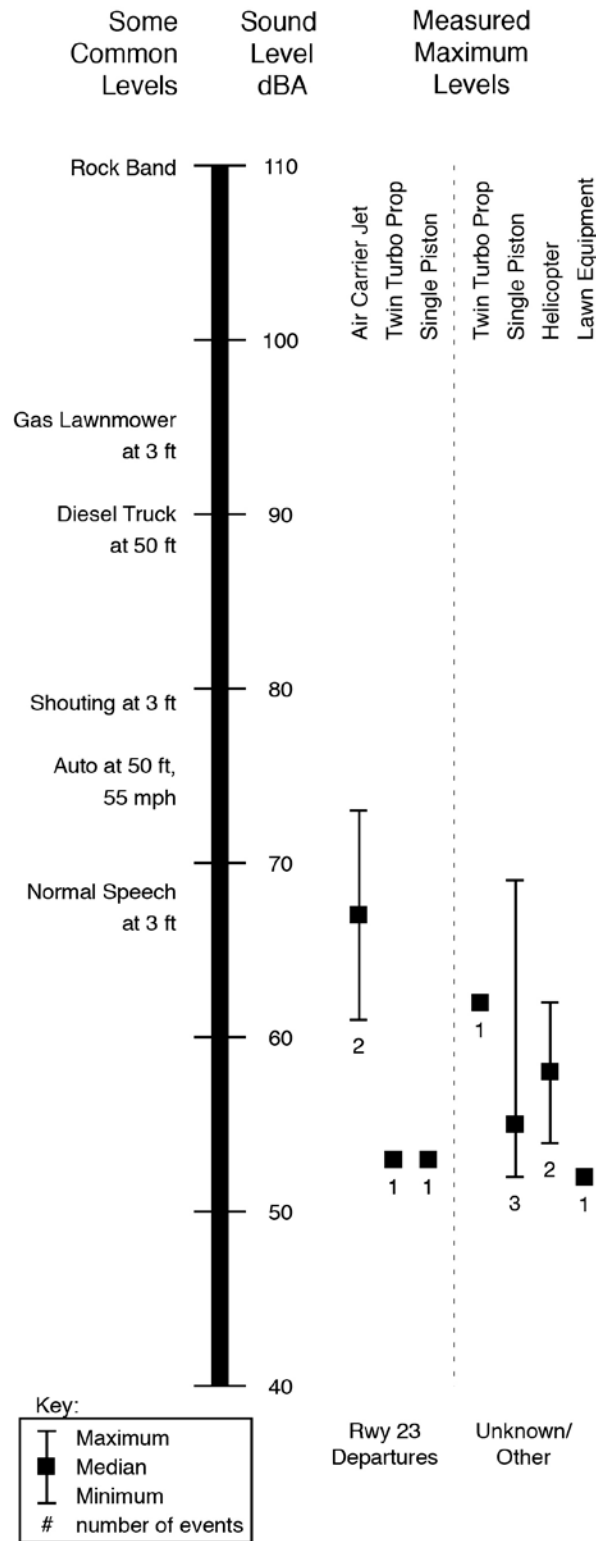
Figure 16 Site 2 Measured Maximum A-Weighted Levels
Source: HMMH June 2013

As shown in Figure 16, a jet departure produced the highest L_{max} of 73 dBA. A variety of propeller aircraft produced measurable levels. In some cases, the observer could not determine the runway used and type of operation because of the distance from the site to the runway and the fact that the observer could hear but not see the aircraft. The L_{max} for one single-piston operation was 69 dBA.

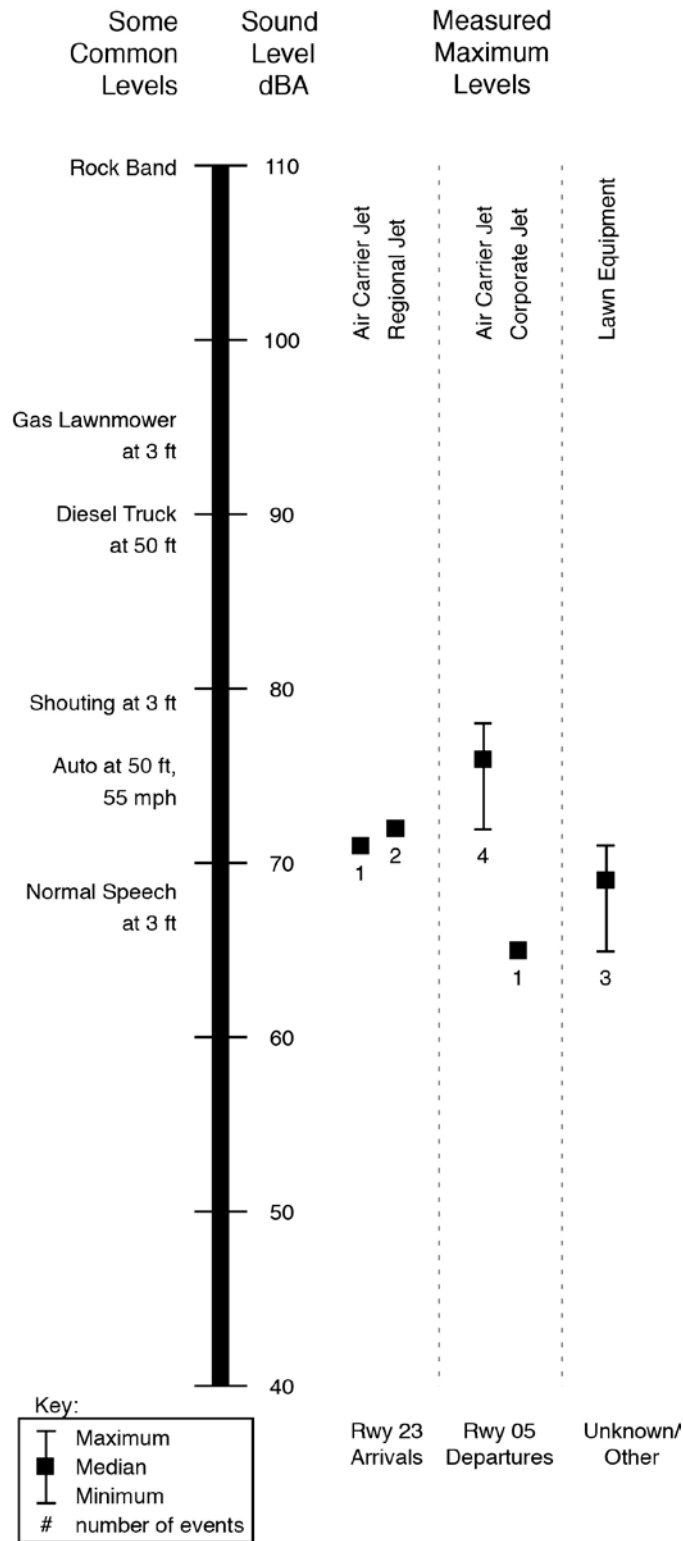
Figure 22 Site 4 Measured Maximum A-Weighted Levels
 Source: HMMH, June 2013

Runway 5 departures and Runway 23 arrivals were the principal aircraft operations affecting the site during the measurements. Jet aircraft were the sole source of measured aircraft noise events, with a maximum L_{max} value of 78 dBA for Runway 5 departures and 72 dBA for Runway 23 arrivals.

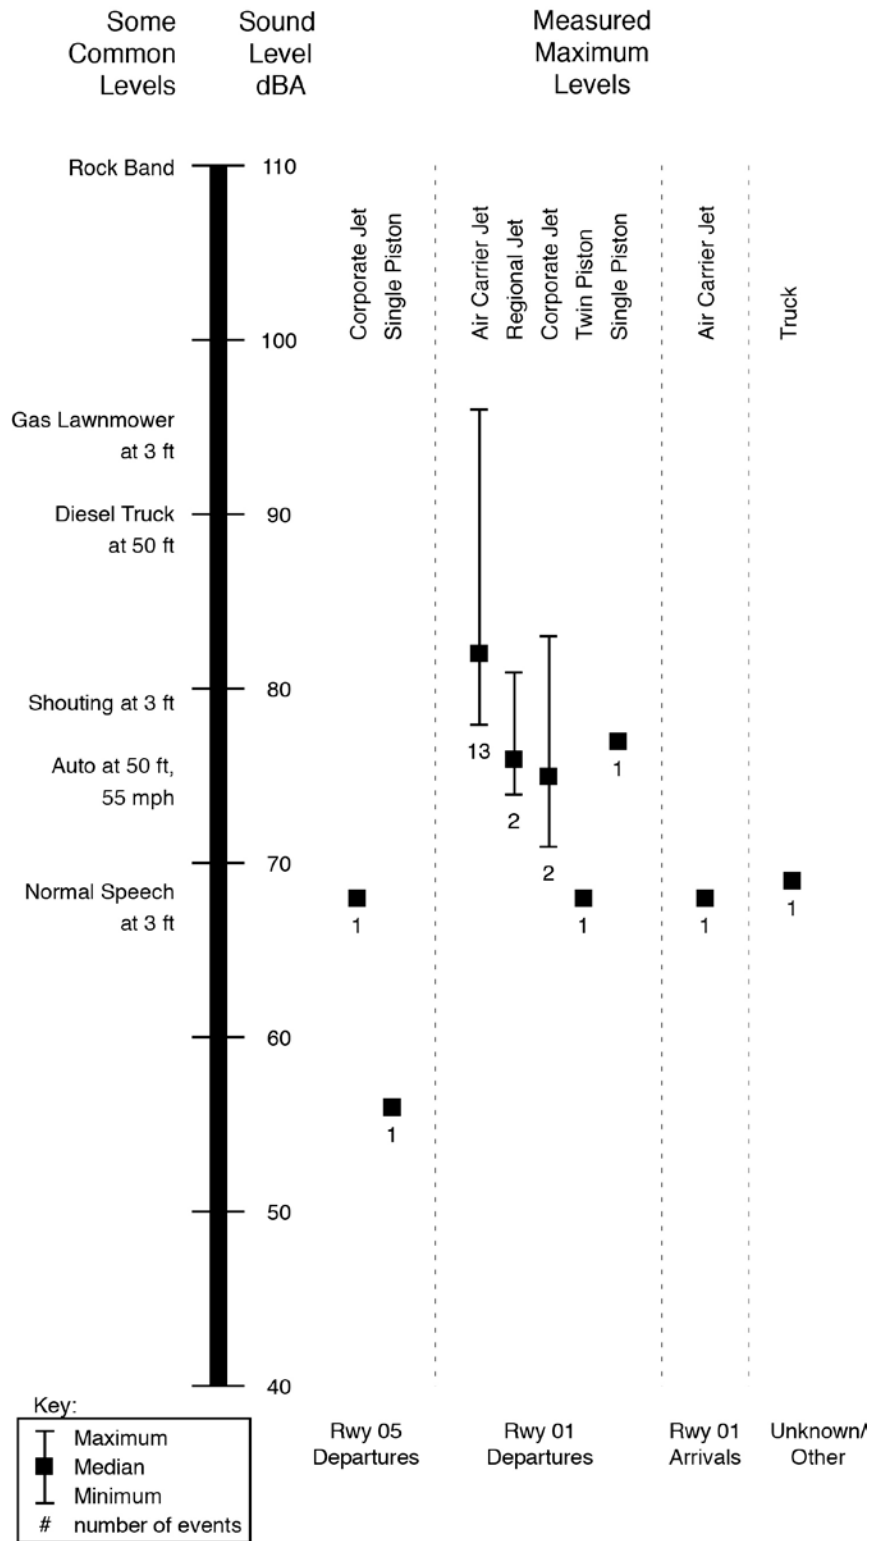
Figure 25 Site 5 Measured Maximum A-Weighted Levels
Source: HMMH, June 2013

As shown in Figure 25, Runway 1 departures were the principal operations affecting the site during the measurements. Air carrier jets were responsible for nearly 60% of the identified noise events. Overall, air carrier departures at Site 5 caused the highest L_{max} values recorded at any site during the measurement period. One air carrier jet departure produced the highest overall maximum L_{max} measured at any site, of 96 dBA. Regional jets and corporate jets departing from Runway 1 also caused relatively high L_{max} values of 81 dBA and 83 dBA, respectively.

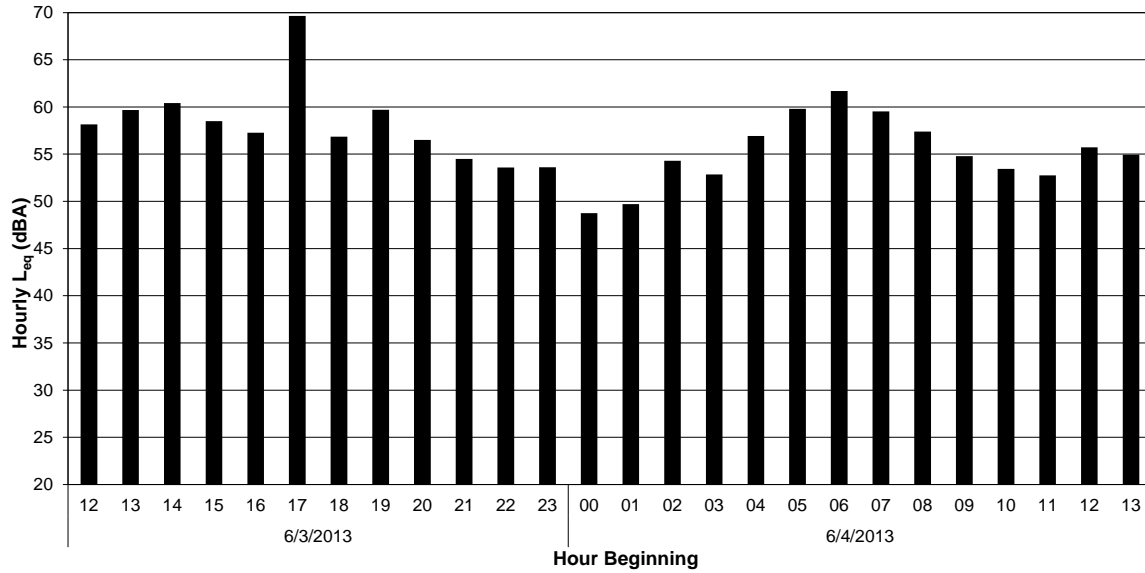
Figure 26 Site 5 Measured Hourly Noise Levels (L_{eq}), Full Duration
Source: HMMH, June 2013

Approximately 26 hours of monitoring were conducted at Site 5, including 24 consecutive full hours starting at 1 p.m. (hour 13) on June 3. As shown in Figure 26, the hourly L_{eq} values ranged from 49 to 70 dBA. The general variation in hourly L_{eq} is consistent with activity at the airport and normal patterns of non-aircraft activities in a residential setting. An MD-88 departure on Runway 1, with an SEL of 105 dBA (the same event with the L_{max} of 96 dBA), caused the abnormally high L_{eq} value on June 3 for the hour starting at 5 p.m. (hour 17).

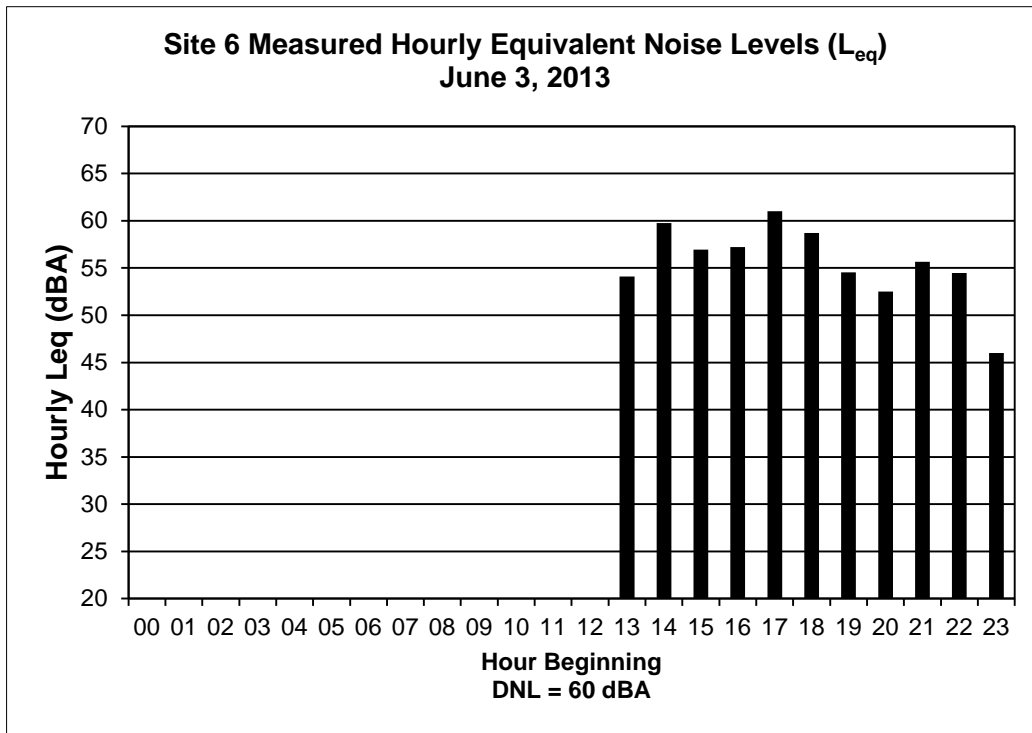
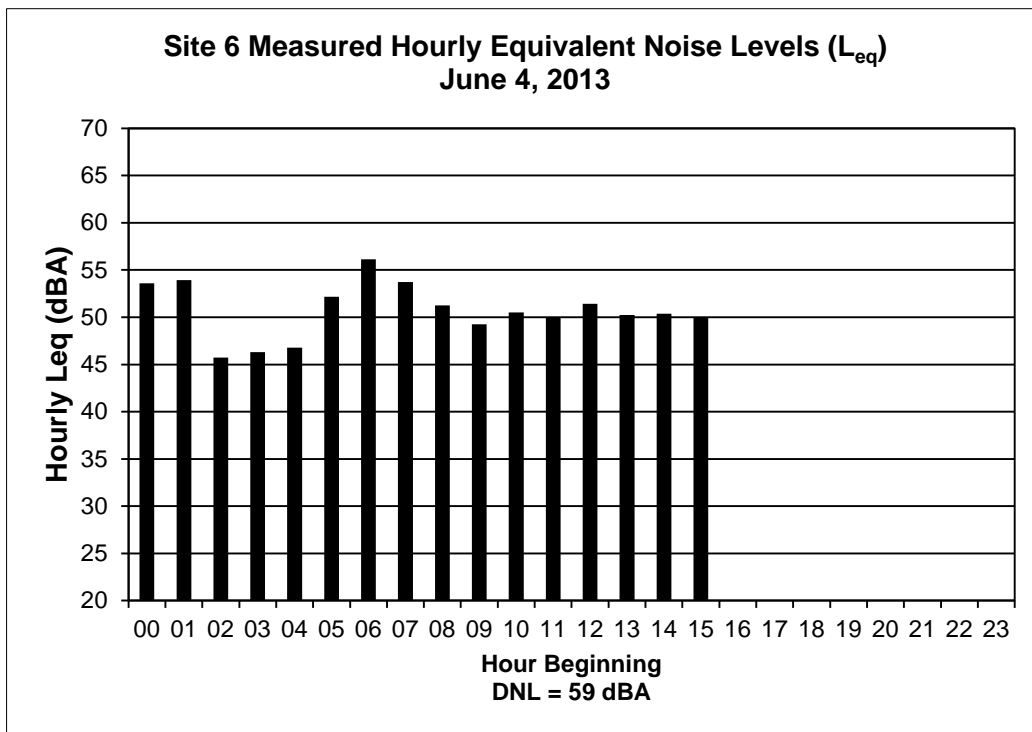
Figure 30 Site 6 Measured Hourly Noise Levels (L_{eq}), Calendar Days
Source: HMMH, June 2013

Site 6 measurements covered 27 hours. As shown in Figure 29, the hourly L_{eq} approximately ranged from 46 to 61 dBA. The highest hourly L_{eq} was for the hour starting at 5 p.m. (hour 17) on the afternoon of June 3. A relatively high number of jet aircraft arriving on Runway 01 were the cause of the somewhat elevated exposure in that hour. The monitor operating at Site 5 during this same hour also measured a high exposure level during this hour.
